PERFORMANCE OF LI-1542 REUSABLE SURFACE
INSULATION SYSTEM IN A HYPERSONIC STREAM

by L. Roane Hunt and Herman L. Bohon

April 1974

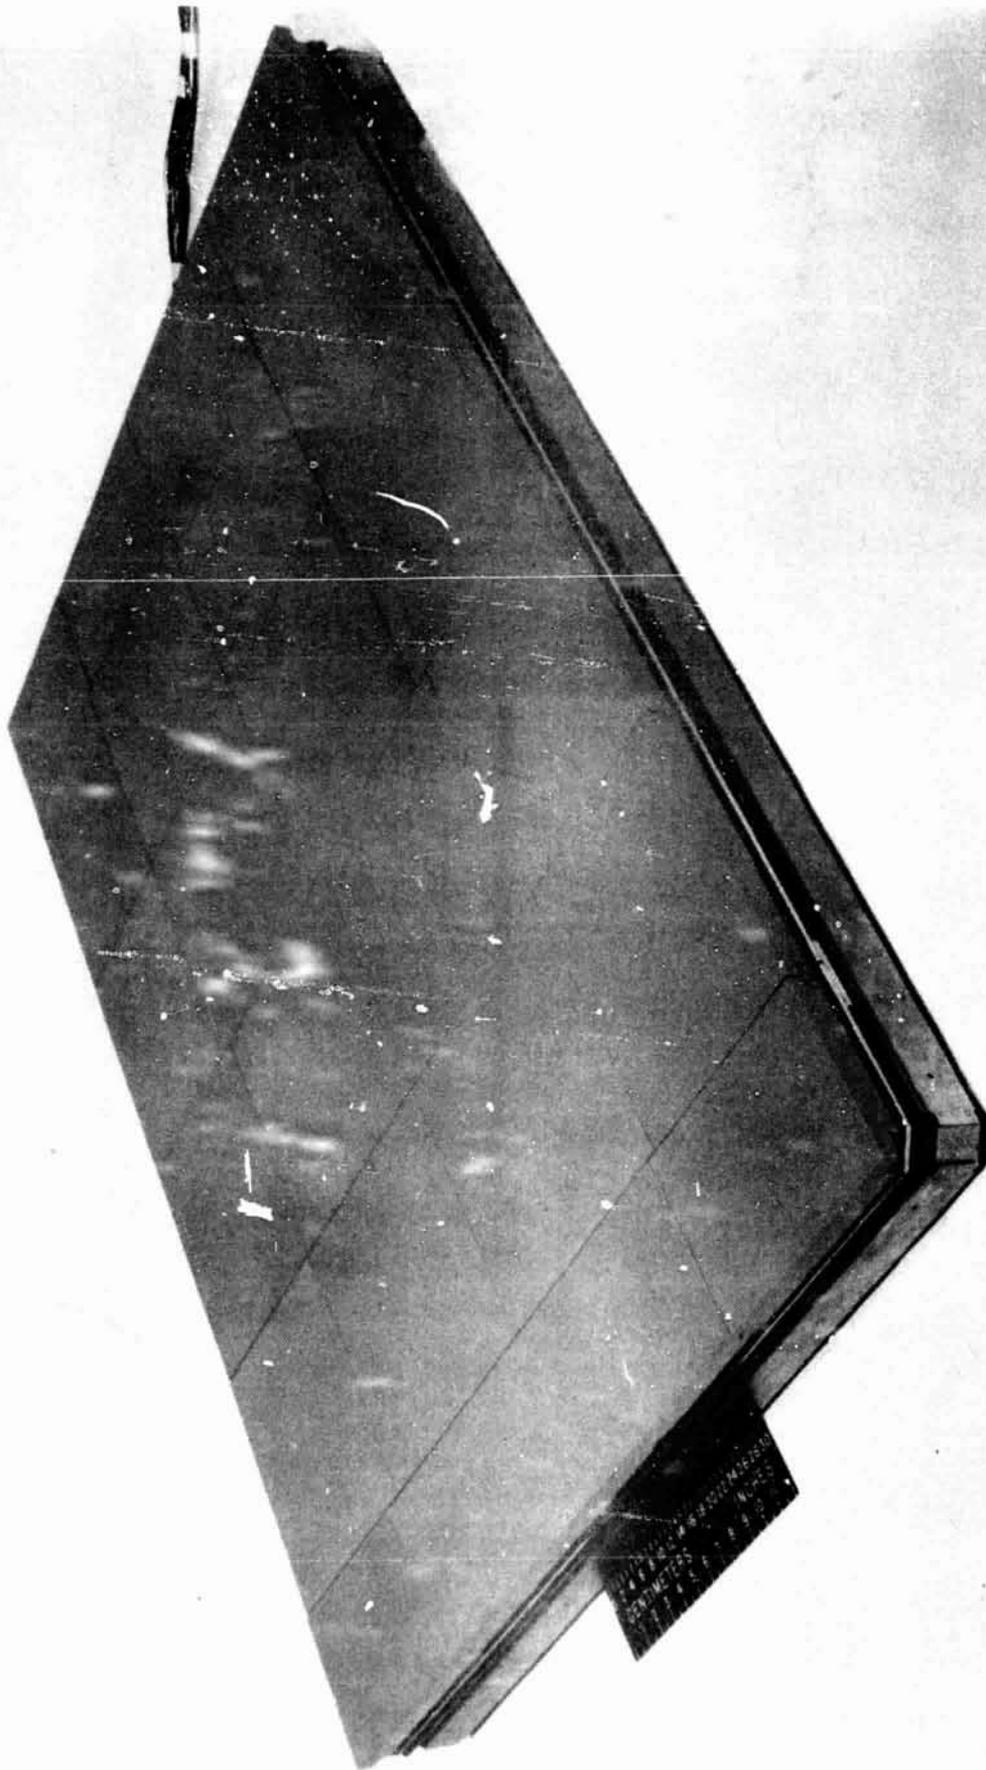
Figure 1. - Photograph of test panel with RSI tiles.

The TPS panel consists of an array of RSI tiles bonded to stringer-stiffened beryllium subpanels mounted on a titanium frame (ref. 3). The model shown in figure 1 is 108 X 152 X 12.7 cm. The primary test article consists of 8 tiles on two subpanels. Top and bottom views of a beryllium subpanel are shown in figure 2. The subpanels are bolted on the titanium frame shown in figure 3. The frame in figure 3(a) is covered by .64 cm titanium plate around the area reserved for the two subpanels. These plates serve as a bonding surface for the peripheral tiles. An aluminum base plate (.8 mm thickness) was attached directly to the bottom of the frame to absorb the internal radiation of the test panel. The

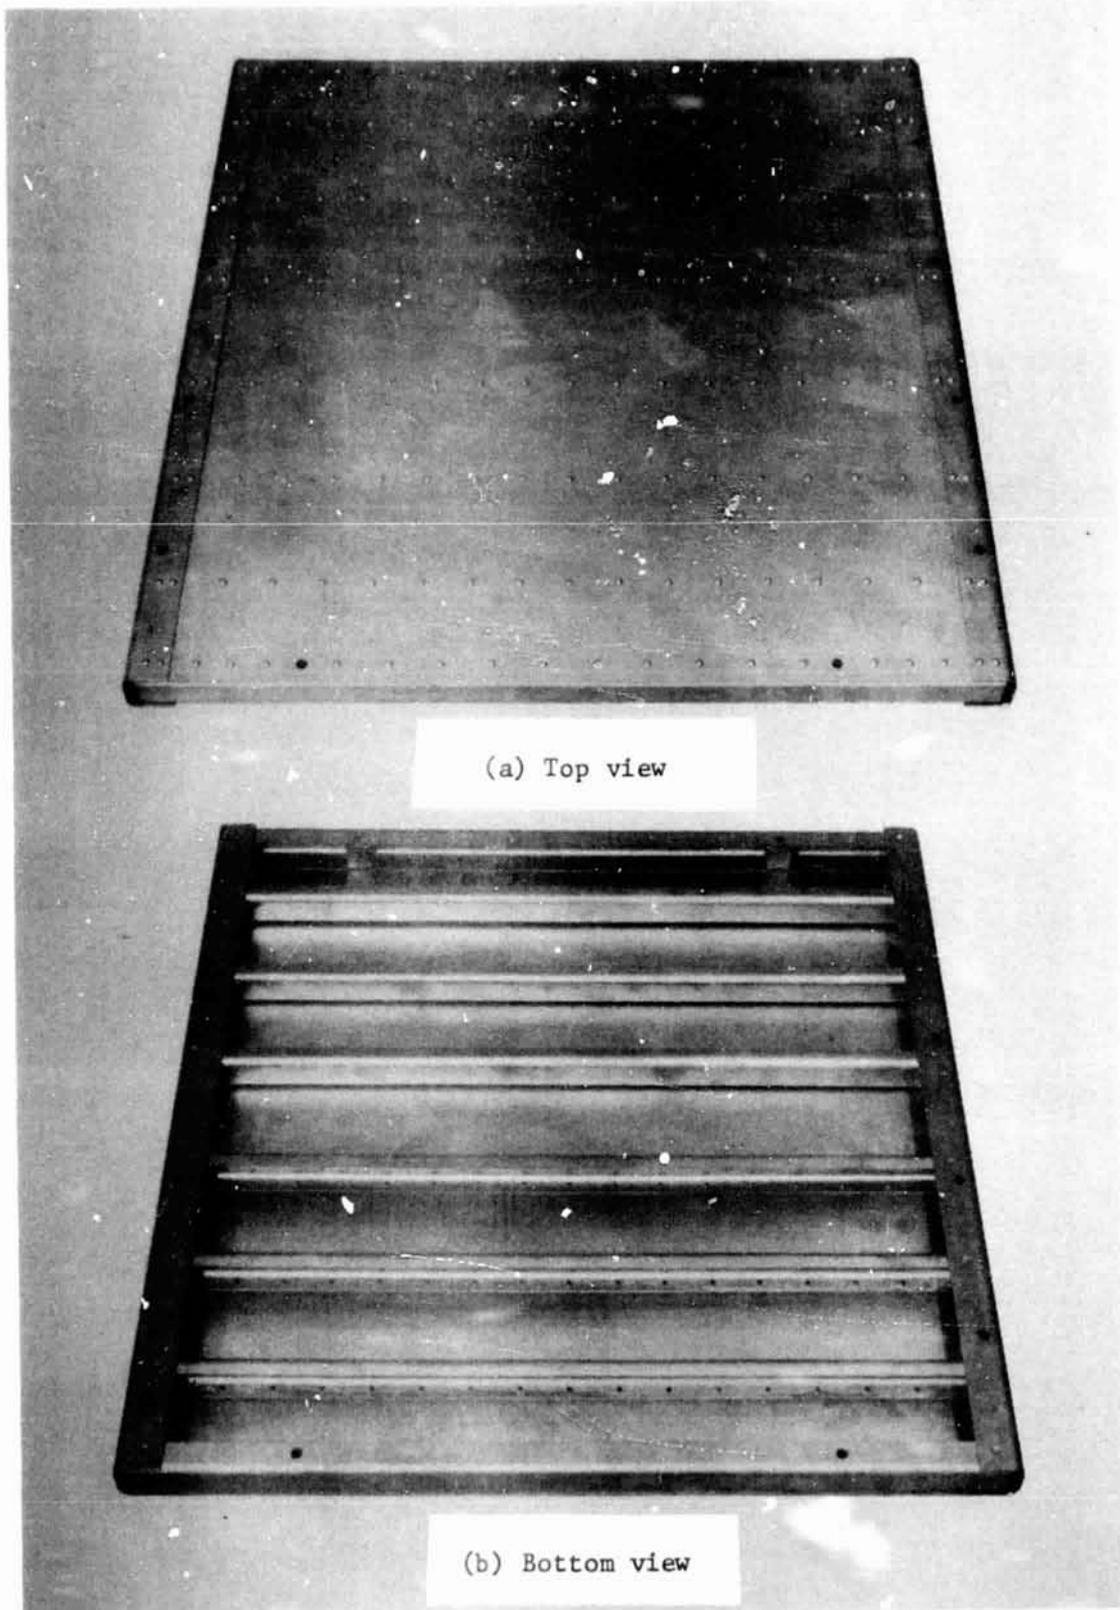
Figure 2. - Photographs of stringer-stiffened beryllium subpanel.

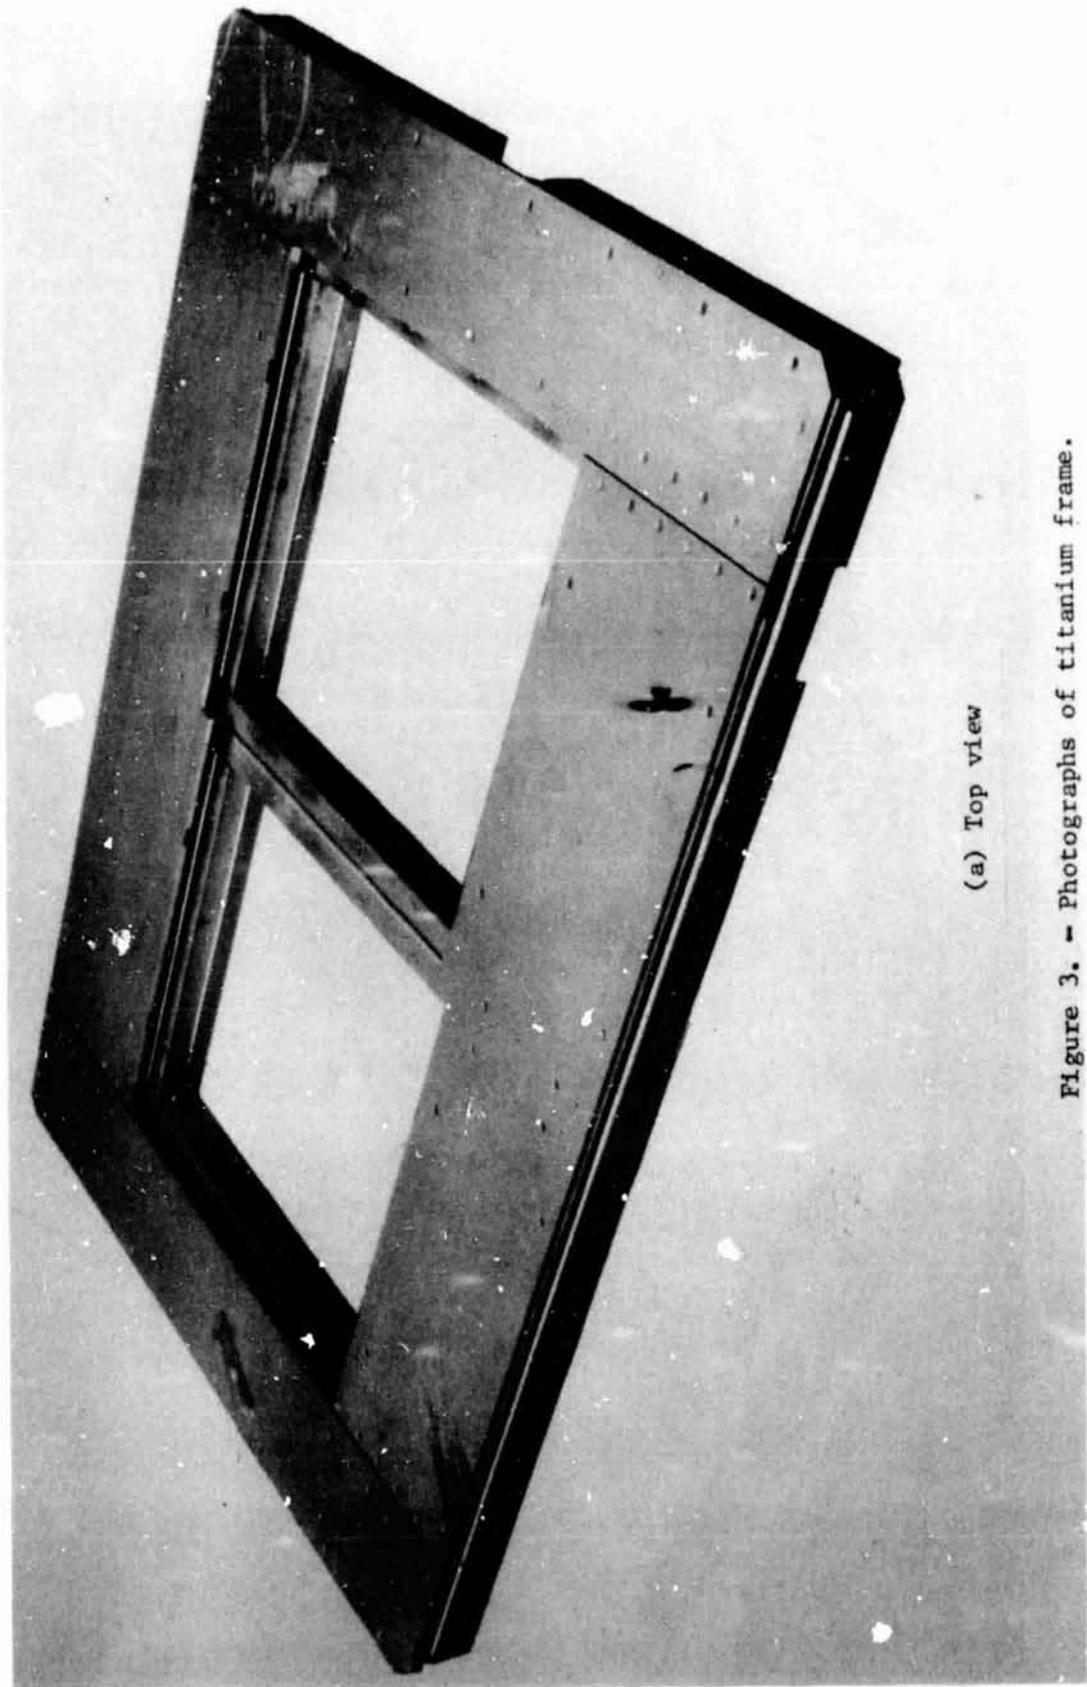
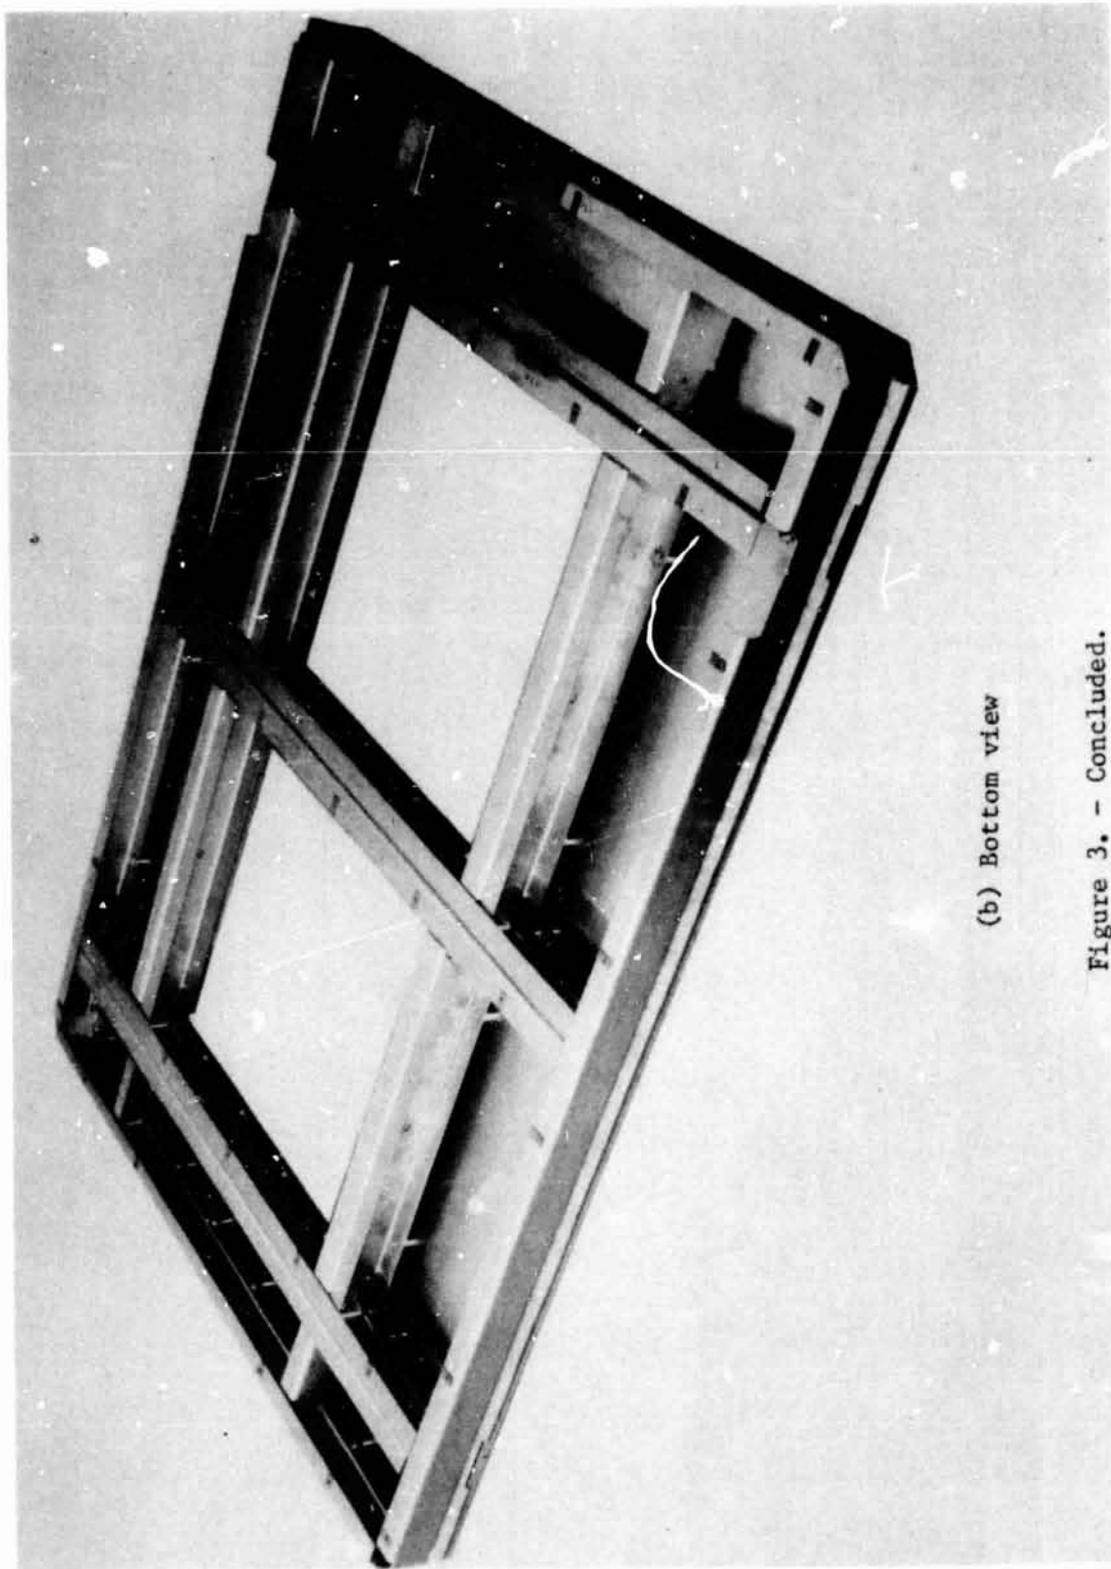
(a) Top view

Figure 3. - Photographs of titanium frame.

(b) Bottom view

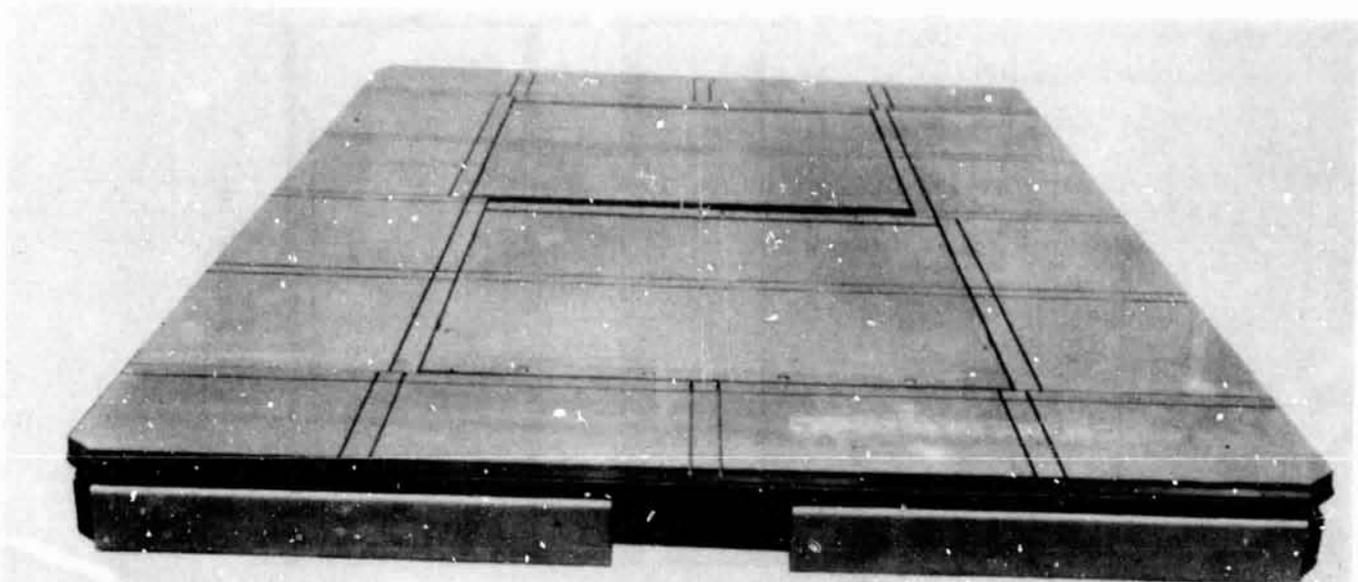
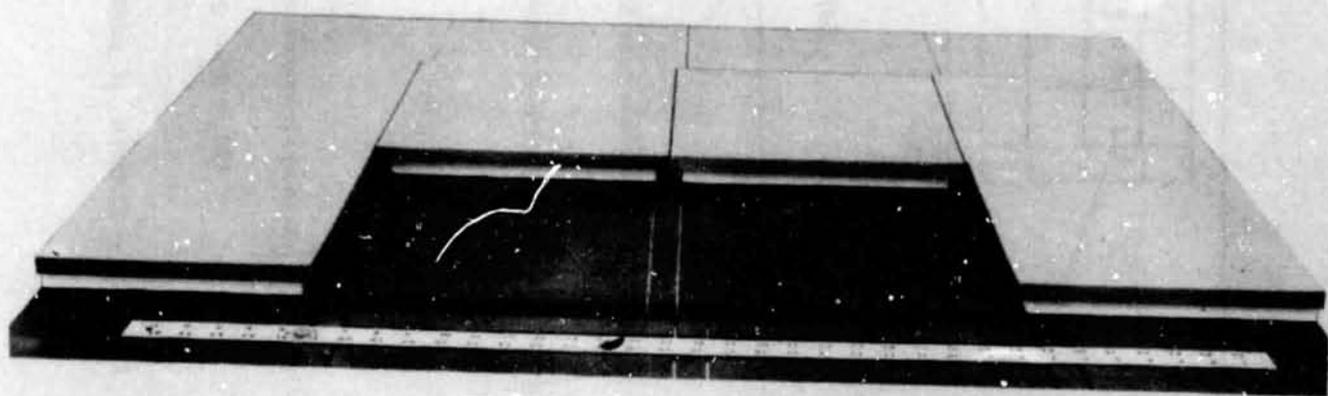
(a) Substructure with RTV bond.

(b) Tile position

Figure 4. - Photographs illustrating tile assembly.

completed metallic structure with an initial layer of silica rubber bond (RTV-560) is shown in figure 4(a). A portion of the panel with the tiles in place but not bonded is shown in figure 4(b).

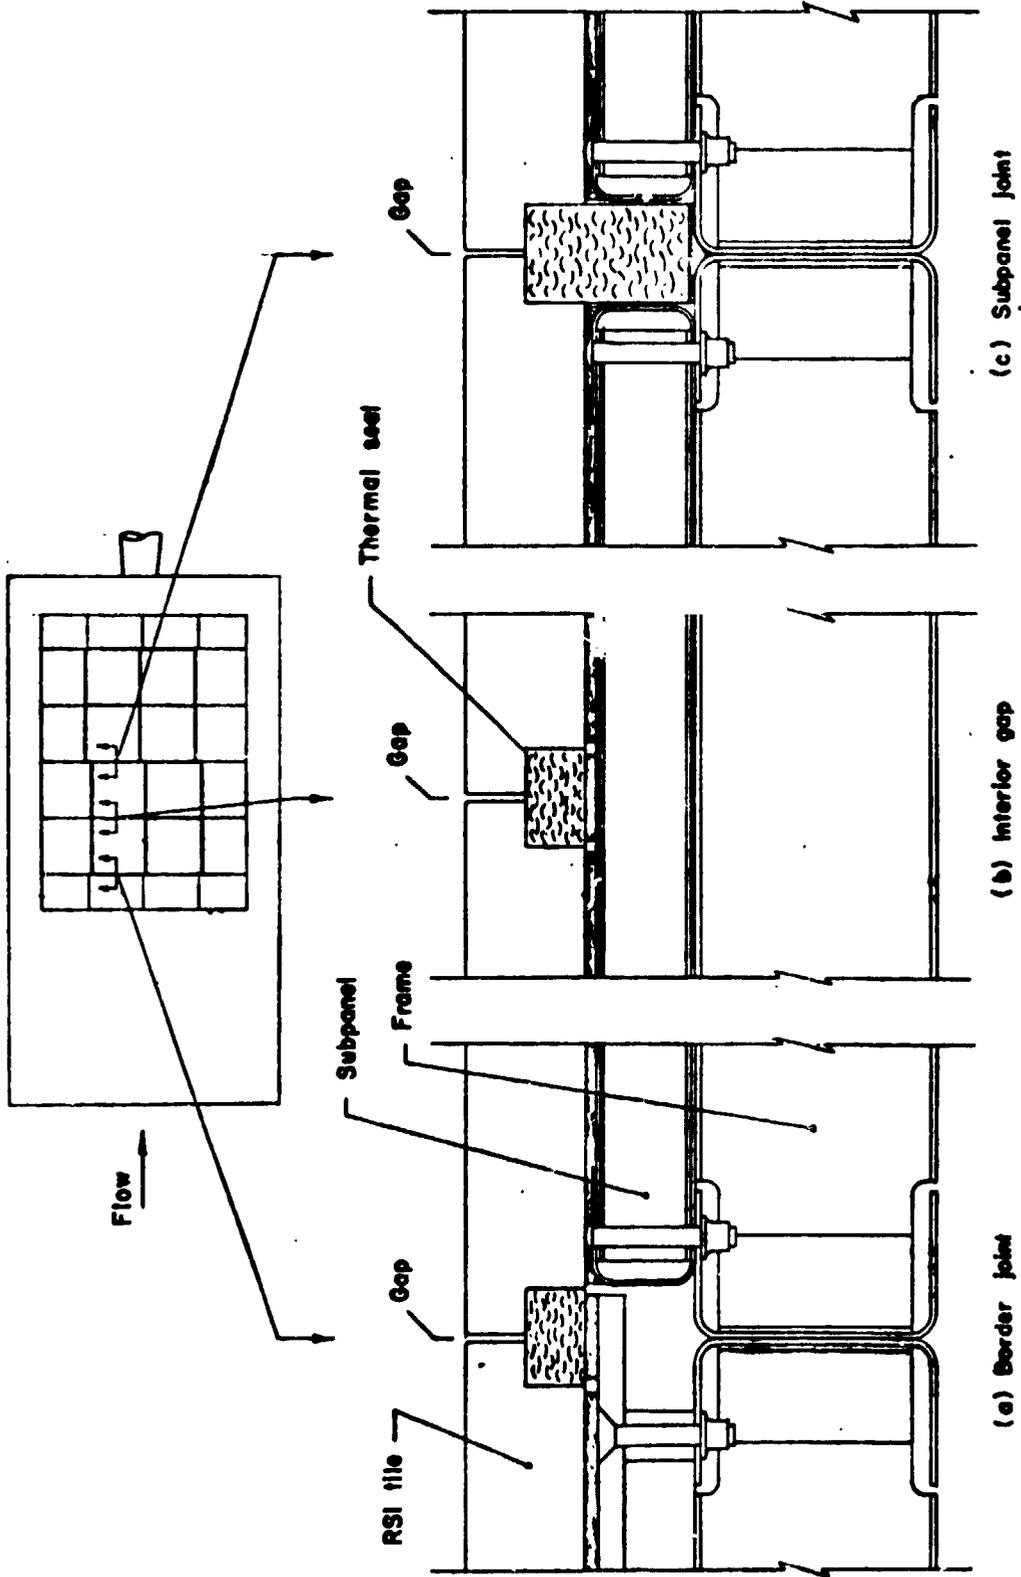
Figure 5. — Schematic of panel tiles and joints.

The RSI tiles (designated LI-1542) are 29.11 X 29.11 X 3.18 cm and consist of rigidized silica fibers (designated LI-1500) with a .25 mm silica carbide coating (designated 0042). A schematic of the tiles and joints is shown in figure 5. The locations of the panel cross-sections are indicated in the plan view in the upper portion of the figure. The details shown are for the border joints around the subpanels, the interior panel gaps, and the common panel joint between the subpanels. (Note the offsets in the tile alignment to interrupt flow in the longitudinal gaps.) The tile edges are undercut (or notched) 1.27 cm to a height of one-half the tile thickness (or 1.59 cm) on all four sides. The surface gaps between tiles are 1.0 mm wide and the tiles are coated on the sides down to the notch. The notch is filled with a thermal seal, a soft silica fibrous material of 96 kg/m^3 density designed to prevent hot gas flow from penetrating the bond and substructure. The top of the thermal seals was coated with the 0042 coating.

thermal response of the longitudinal border gap was expected to be similar to that of the longitudinal interior gap; however, this difference is attributed to hot gas leakage through the thermal seal along the border gaps (see figure 5) and will be discussed in detail in a later section.

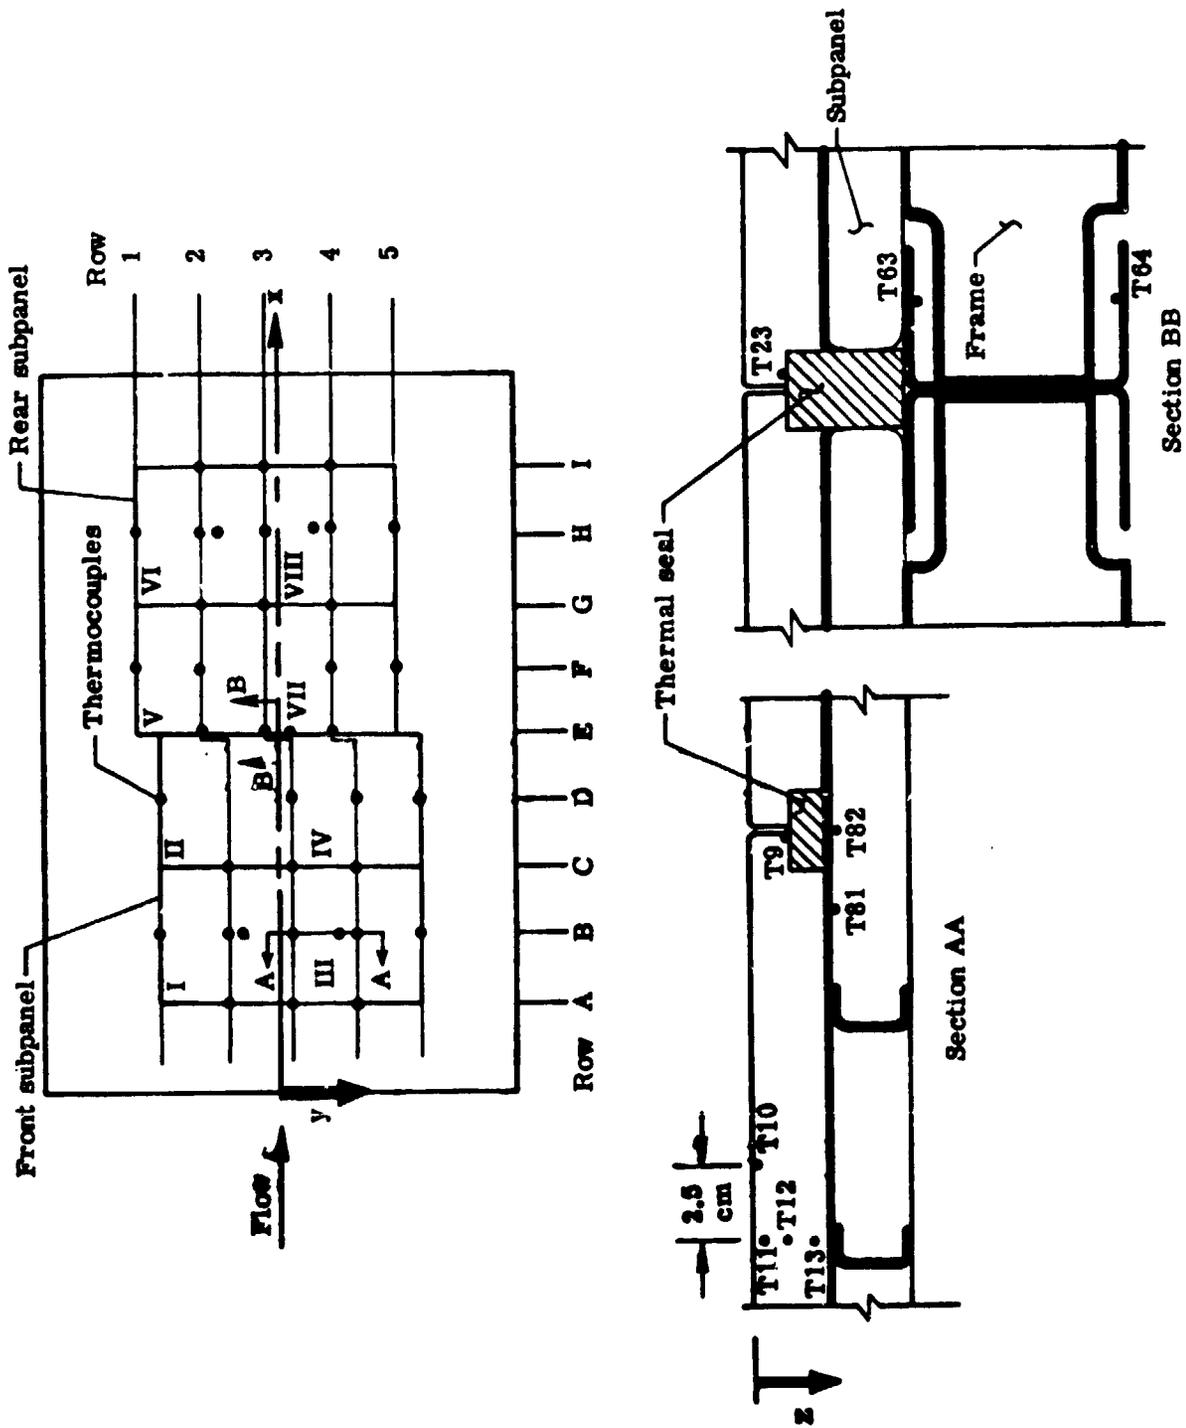
Figure 6.- Sketch of panel structure with thermocouple locations indicated.

The panel is instrumented with 65 thermocouples; 18 through the tile thickness, 27 in the tile gaps, and 20 at various locations on the substructure. The locations of these thermocouples are indicated by figure 6 and in table I. In figure 6, the plan view of the panel is shown with details of the front and rear subpanels indicated. The specific locations of thermocouples are given in table I by the cartesian coordinates and an alphanumeric system is used to identify longitudinal and lateral rows.

The longitudinal rows are jogged to follow the subpanel offset of 2.5 cm. The individual RSI tiles are identified by Roman numerals and the distribution of the thermocouples in the tiles and tile gaps are indicated by the solid symbols in the plan view. Typical in-depth thermocouples are shown in the tile, the gaps, and on the substructure in sections AA and BB at the bottom of figure 6.

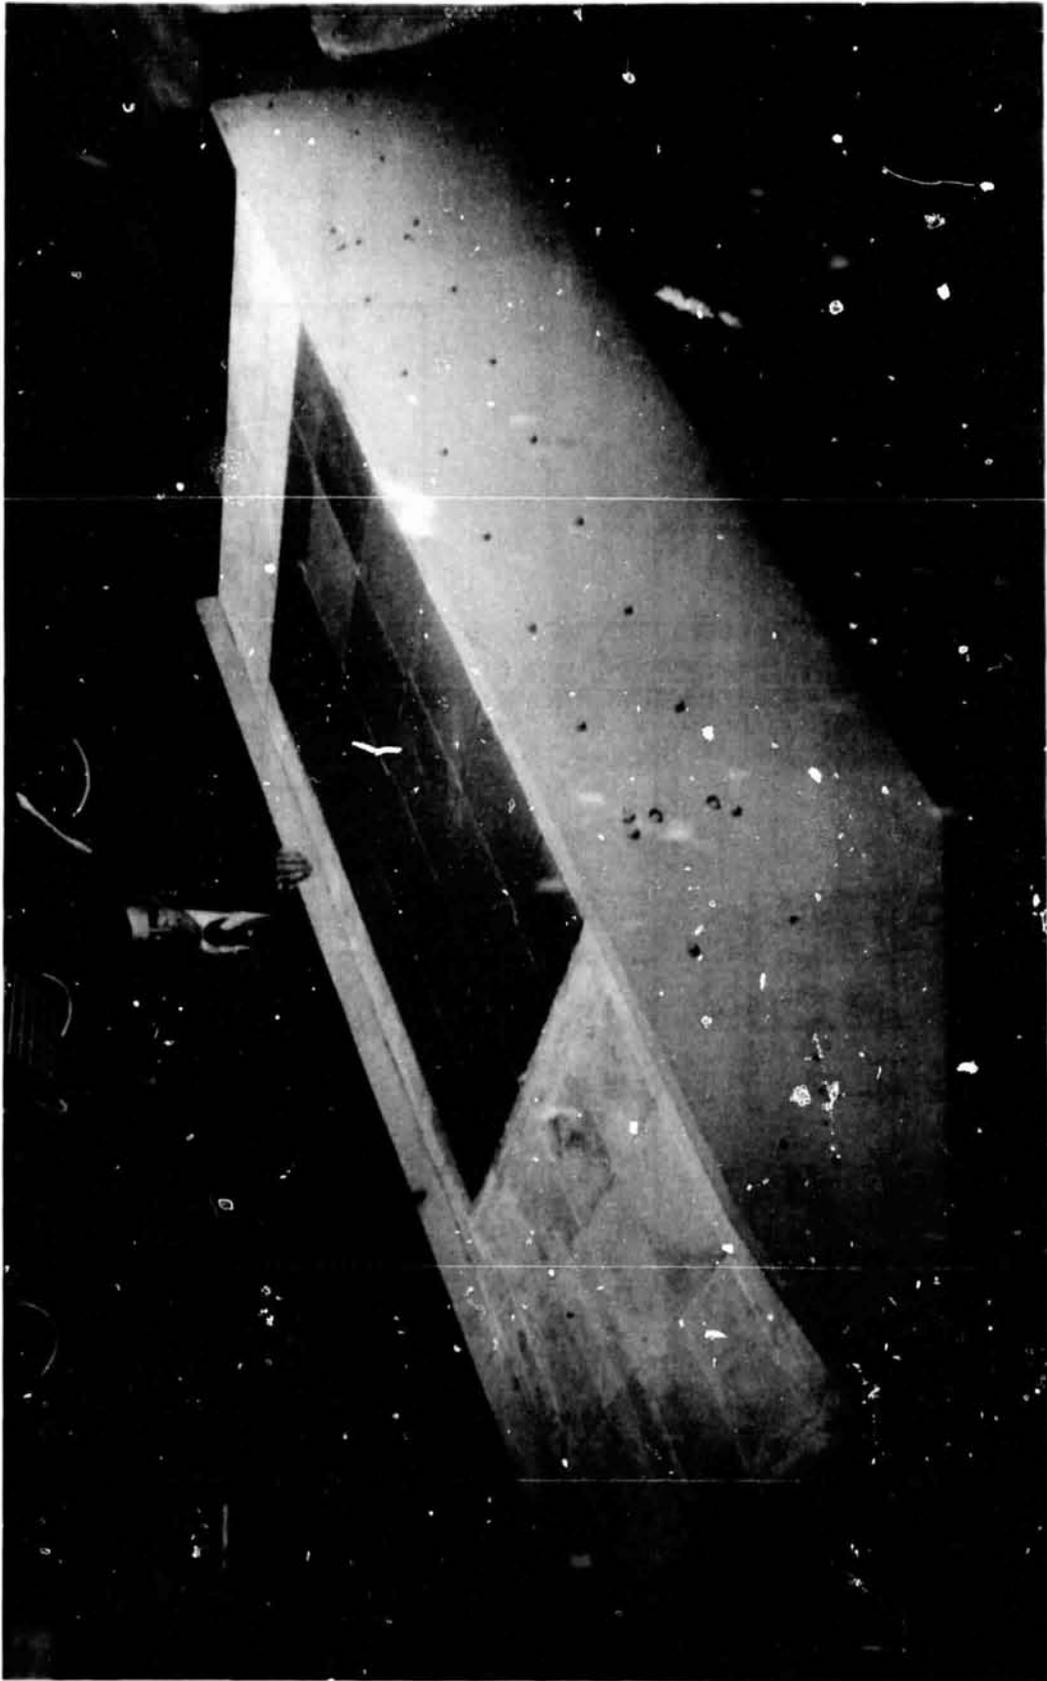
Figure 7. - Photograph of test panel installed in the 8-foot HTST panel holder.

The panel holder is a rectangular slab with a half-wedge sharp leading edge. Flow trips at the leading edge are used to ensure an even turbulent boundary layer over the entire surface, and side plates are used to eliminate cross-flow. Flow conditions over the surface of the panel holder are described in detail in reference 4. The panel holder with the panel installed is shown in figure 7 at a typical test position, pitched at 15° to the tunnel centerline. The top surface of the test panel is set flush with the surface of the panel holder, and the panel is supported from the bottom with longitudinal structural beams. The pressure in a cavity beneath the test panel is controlled to provide differential pressure loading across the panel.

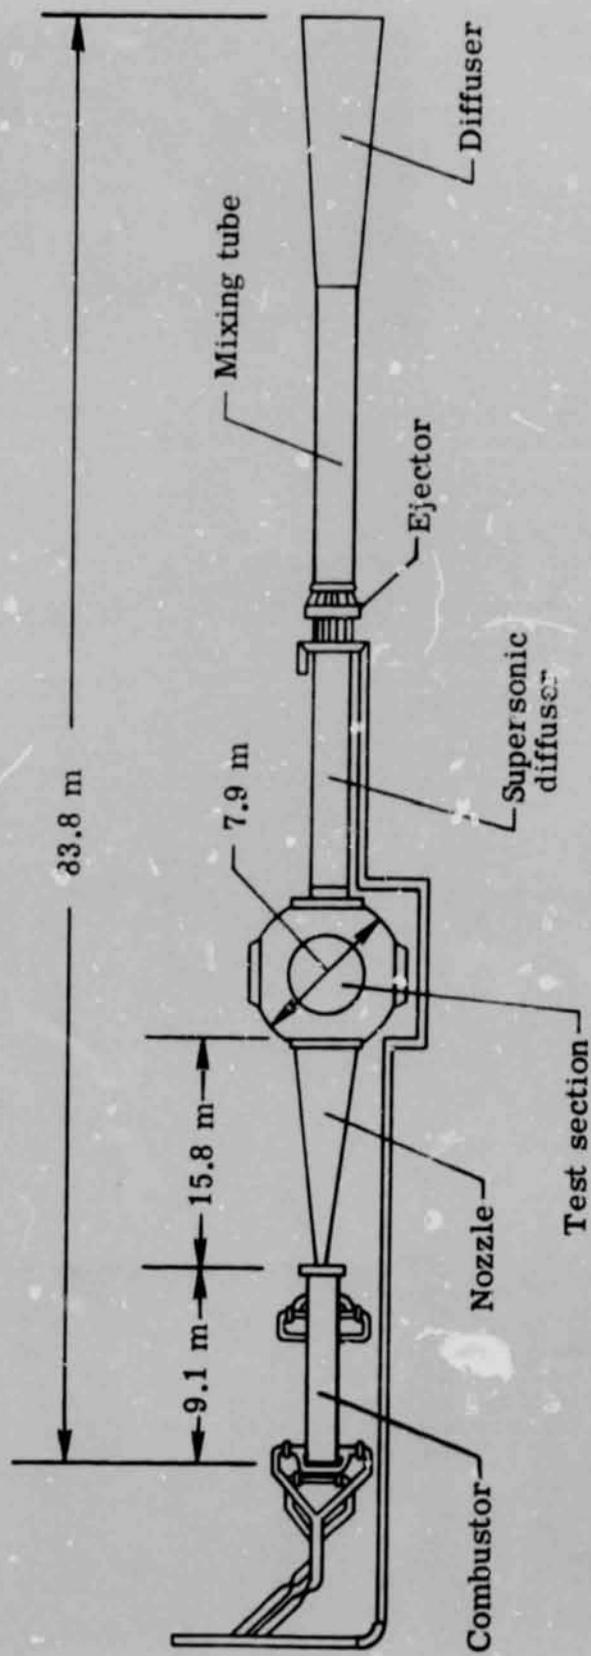
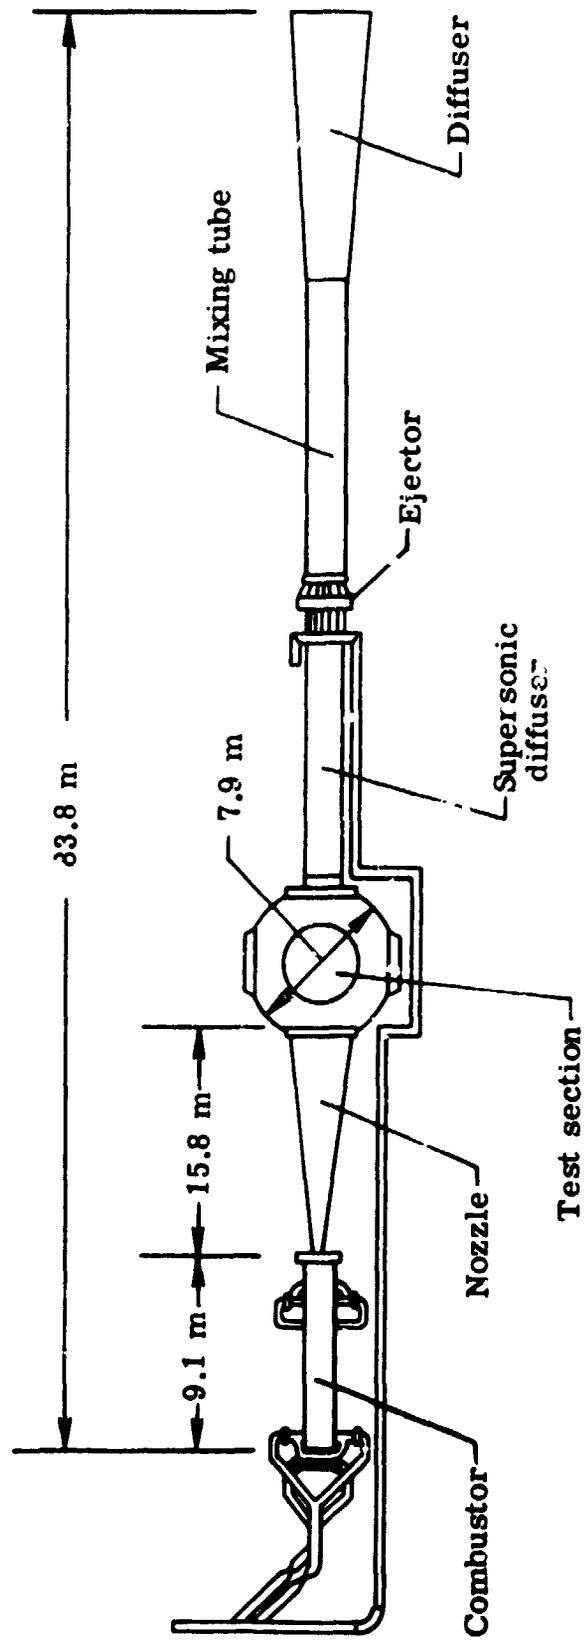
Figure 8.- Schematic drawing of the Langley 8-foot high-temperature structure tunnel.

The tests were conducted in the Langley 8-foot high-temperature structures tunnel (HTST) which is shown schematically in figure 8. This facility is a hypersonic blowdown wind tunnel which uses the combustion products of methane and air as the test medium and operates at a nominal Mach number of 7, at total pressures between 3.4 and 24.1 MPa, and at nominal total temperatures between 1400 K and 2000 K. Corresponding free-stream unit Reynolds numbers are between 1×10^6 and 10×10^6 per meter.

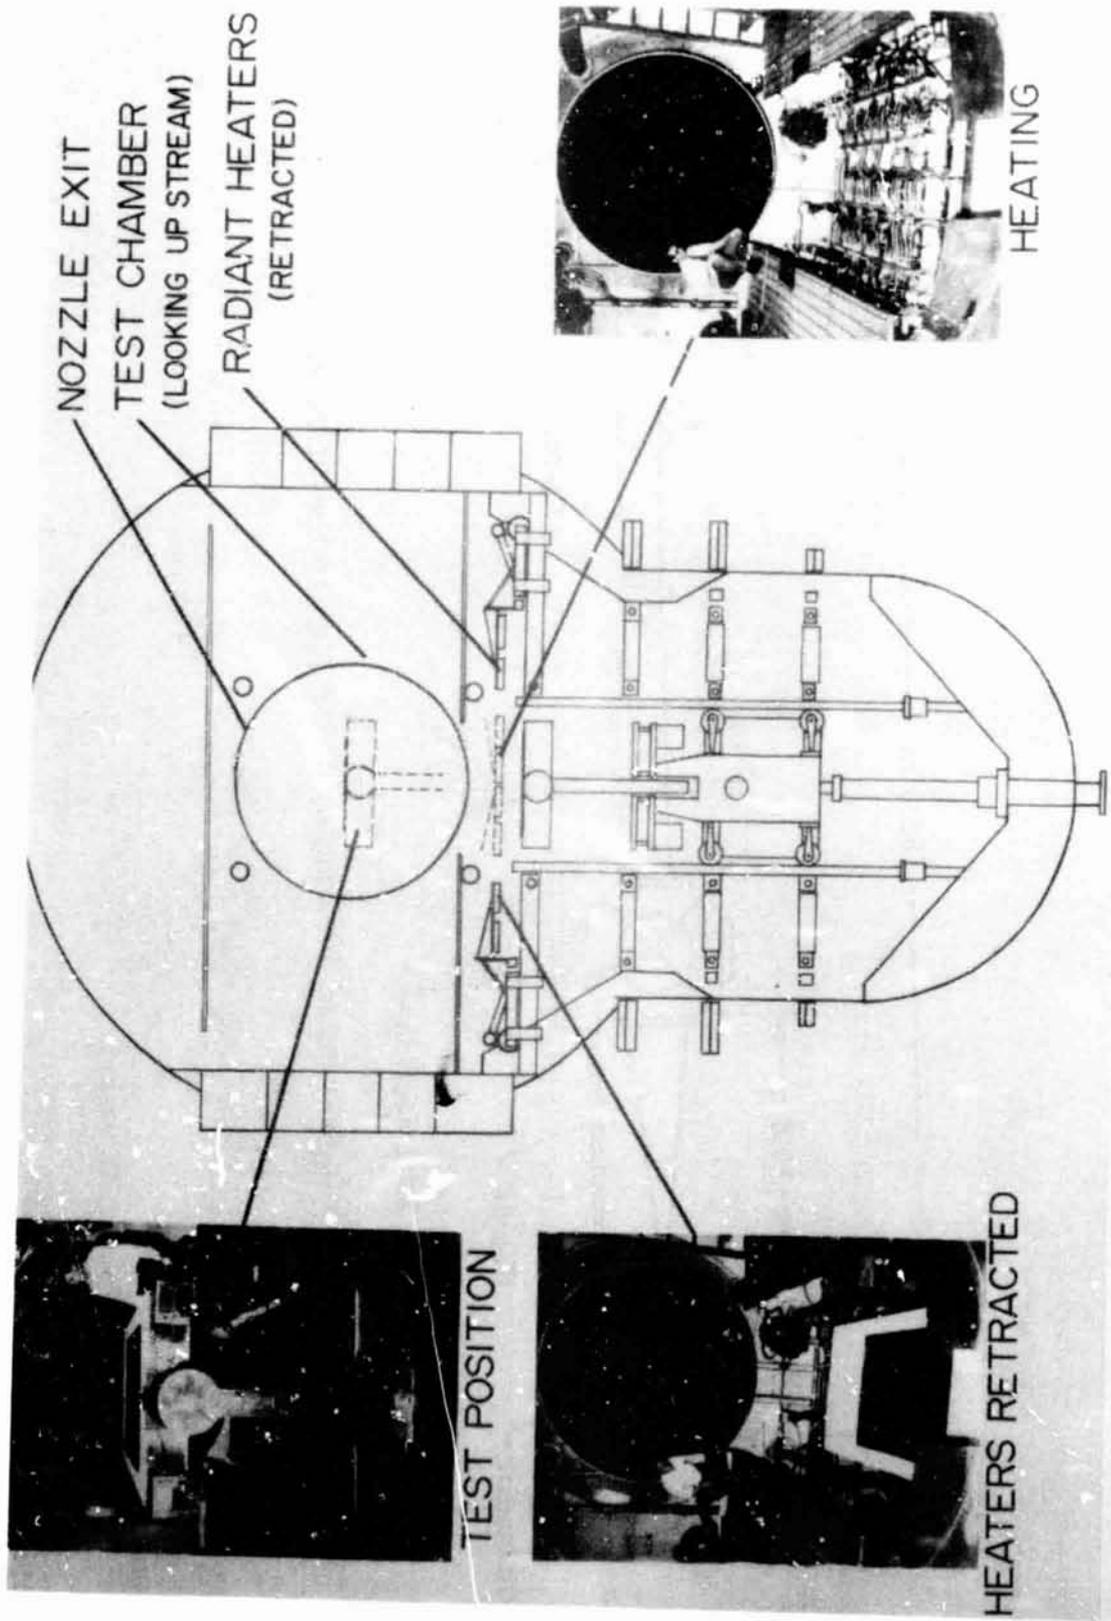
Figure 9. - Illustration of radiant heating apparatus in the 8-foot TST.

To evaluate TPS concepts, an attempt is made to simulate a generalized temperature history associated with the Shuttle reentry trajectory. The reentry time is too long to be simulated in the relatively short test time of the 8-foot HTST; therefore, the radiant-heat apparatus is used in sequence with the wind tunnel to extend the thermal cycle. The radiant heaters are shown in the cross-section of the test chamber in figure 9. The center sketch shows the tunnel nozzle exit, test chamber, and radiant heaters. The insets show (1) the model in the wind-tunnel test position, (2) the model lowered from the test position and the radiant heaters retracted, and (3) the model covered with the radiant heaters.

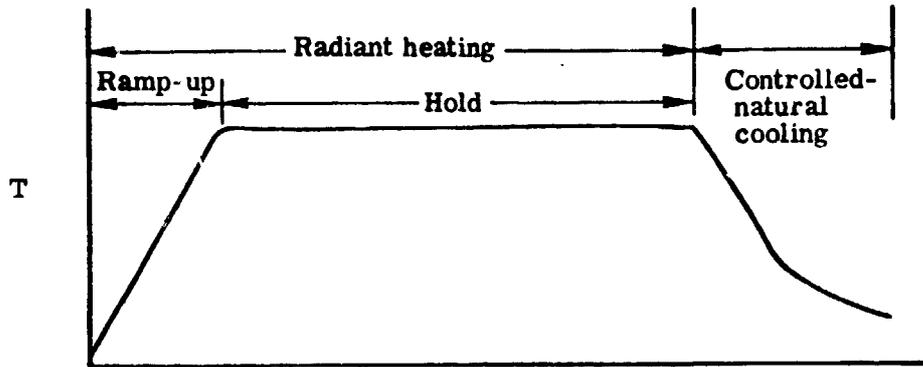
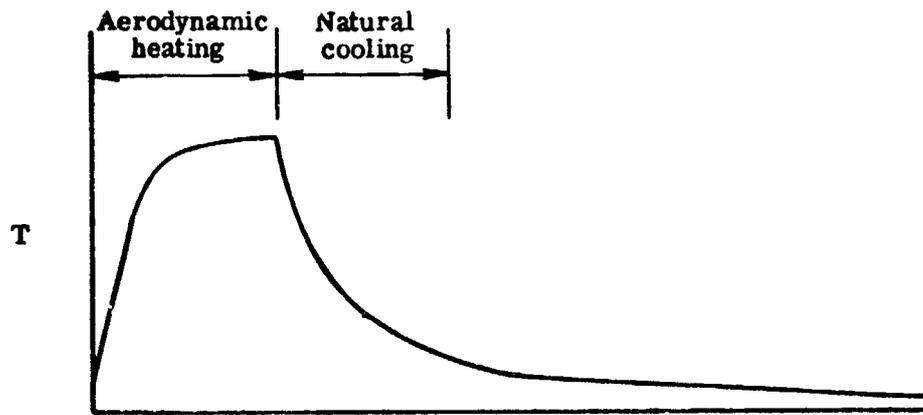
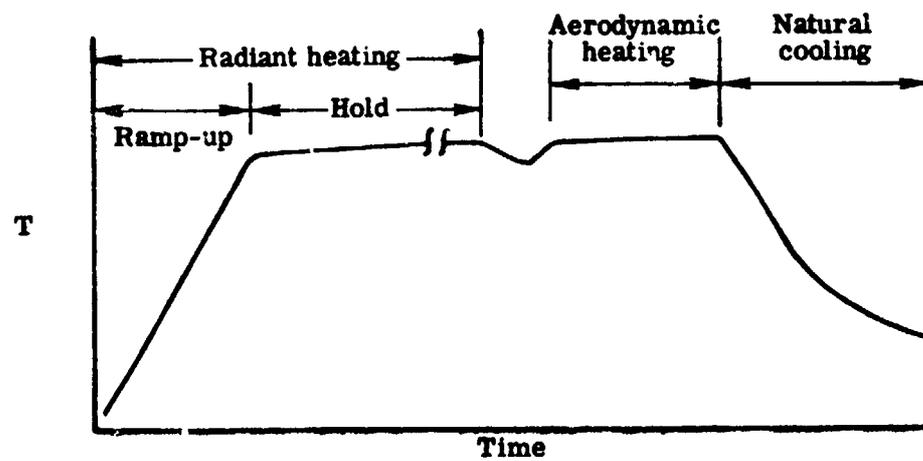
(a) Radiant heating (Mode I).

(b) Aerodynamic heating (Mode II).

(c) Radiant heating and aerodynamic heating (Mode III).

Figure 10.- Typical surface temperature history test modes.

Typical surface temperature histories for the three test modes are presented in figure 10. The steps which constitute a particular mode are also defined in the figure. In test mode I, thermal load is provided by radiant heaters. The temperature history of figure 10(a) is representative

of an entire Shuttle reentry thermal cycle. This cycle is characterized by a linear ramp-up of temperature in about 400 s, a temperature hold at about 1100 K for a nominal time of 1500 s, and a controlled cool-down until natural cooling becomes dominate. In test mode II, thermal loading is aerodynamically provided by the tunnel stream. The panel is inserted into the stream at ambient temperature. The surface temperature rises rapidly, approaches a steady-state level within the test duration of about 30 s, and decreases naturally after panel retraction from the stream. Mode III is a combination of mode I and mode II. The nominal hold time is 700 s and the tunnel stream exposure time is 40 s. In this test mode, close coordination is required to remove heaters and then insert the model into the test stream to minimize heat loss between heating periods.
